Westech Inspection, Inc. provides out of service tank bottom inspection services. We have a broad range of inspection applications to insure the condition of your tank.

MFE Tank Bottom Scanning is performed by skilled operators, using the **MFE 2412 Mark II Magnetic Flux Leakage (MFL) Tank Floor Scanner**. Design changes have doubled the amount of magnetic material allowing inspection of **Thicker Plates** and through **Thicker Coatings**.

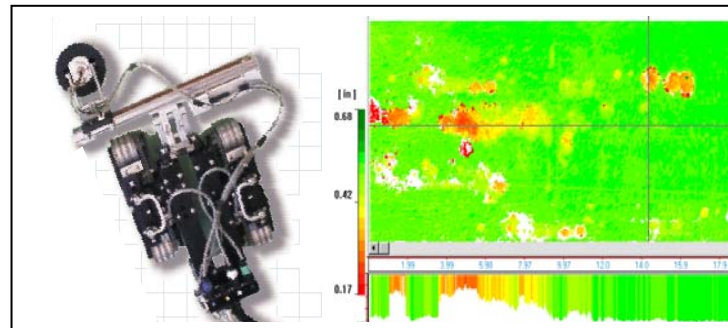
Computerized Crawler / Corrosion Map

C-Scan Displays a combination of B-Scan data with a *Thickness Map* of entire area (Corrosion Mapping)

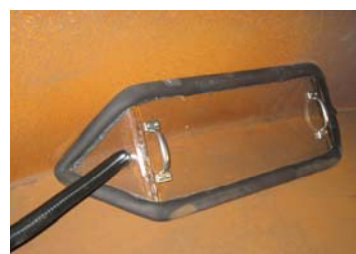
Corner Welds

VAC Box Weld Inspection

Custom built by Westech Inspection
